Federal Motor Carrier Safety Administration
Office of Analysis, Research and Technology

Smart Infrared Inspection System

Preliminary Field Test Results

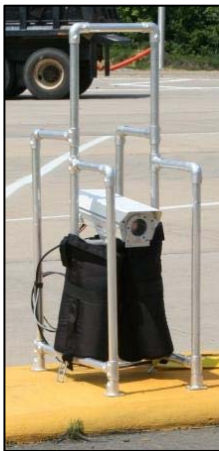
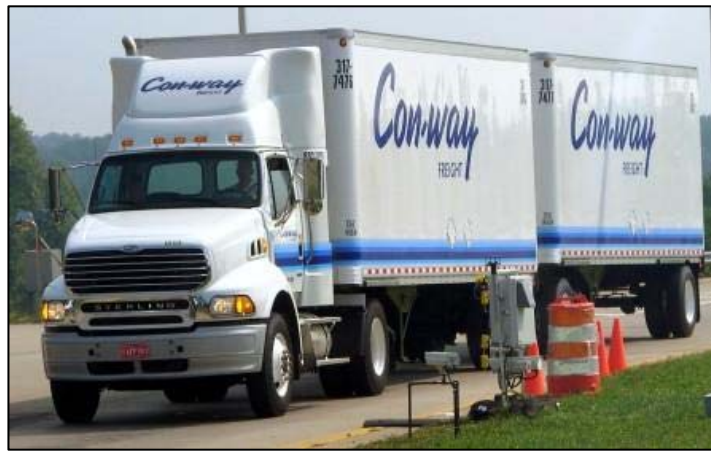
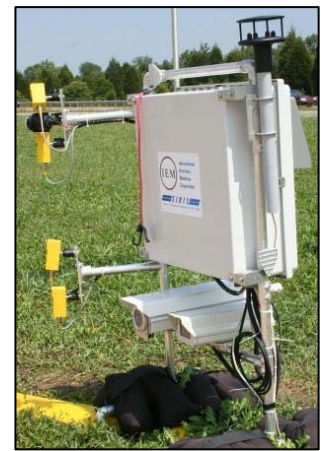
- ◆ Grant for a demonstration of thermal imaging technologies
 - Identify, in real time, faults and failures in tires, brakes and bearings mounted on commercial motor vehicles
 - Employ system along the interstate
 - Explore whether statistical tools can be developed that can predict impending tire, brake, or bearing failures

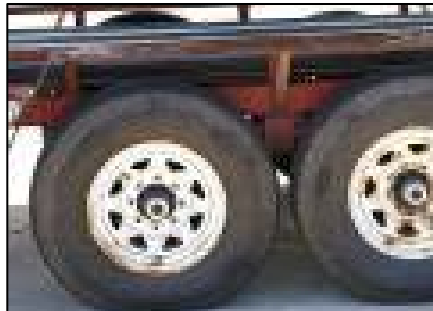
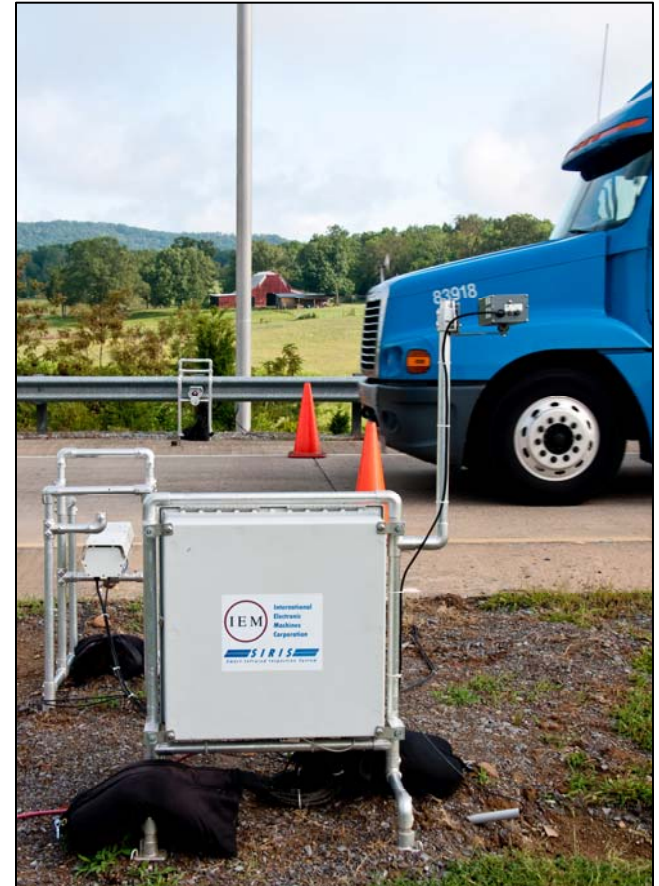
- ◆ \$1.4 M Research Grant
- ◆ 3-year Project
- ◆ Grant competitively awarded September 2006 to IEM, Inc. of Troy, NY
- ◆ Supplemental \$500K from NYSERDA for improved high speed performance

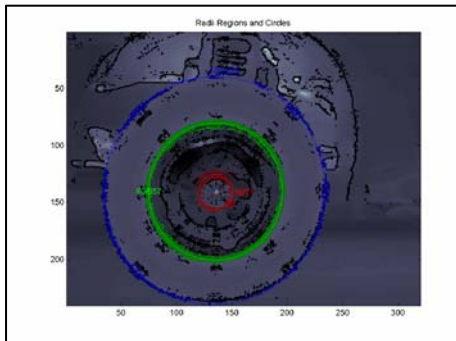
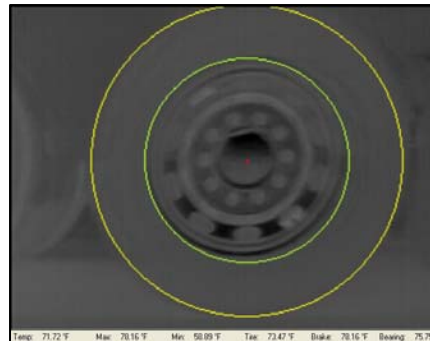
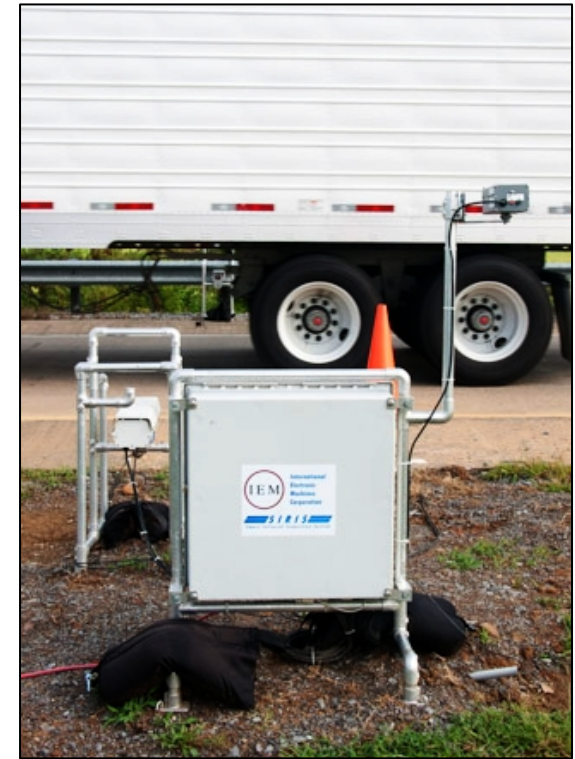
- ◆ Measure wheel temperatures on passing vehicles
- ◆ Segment wheels into areas of interest
- ◆ Automatically flag those meeting certain criteria
- ◆ Alert inspectors when vehicle is flagged

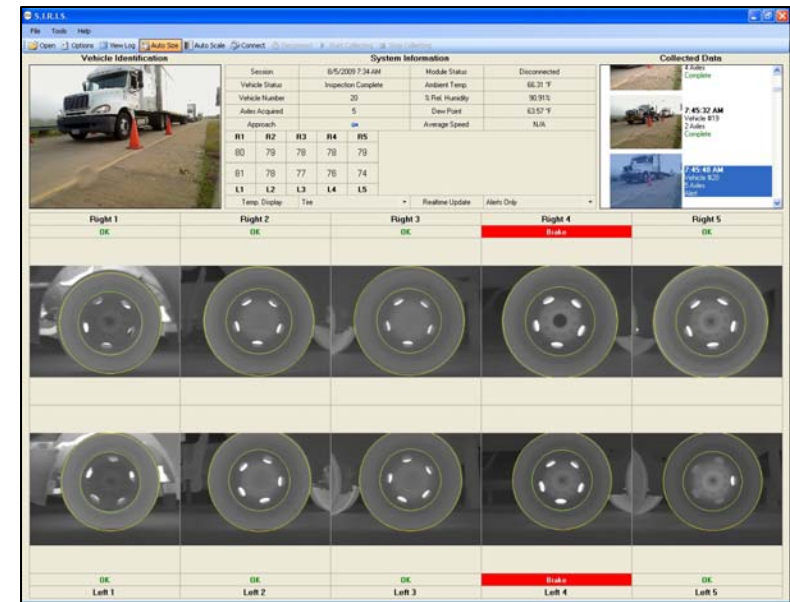
Current SIRIS User Interface

- ◆ System triggers on wheel ends and looks at both sides of the vehicle
- ◆ System looks at three areas specifically:
 - Tire
 - Wheel (brake area)
 - Hub
- ◆ *Automatically* evaluates each vehicle and alerts when problem noted
- ◆ Vehicles currently identified by image during inspection
- ◆ Currently works at speeds up to about 20 mph

(this vehicle placed OOS)
